DEPARTMENT OF NATURAL RESOURCES  
DIVISION OF OIL, GAS AND MINING

RE: Site Inspection, U. S. Energy Corporation, Velvet Mine, M/037/040, San Juan County, Utah

Date of Inspection: August 15, 2002  
Time of Inspection: about 4:30-5:30 p.m.  
Conditions: Clear, 80's  
Participants: Doug Jensen and Paul Baker, DOGM

Photographs  
M/037/040  
Velvet Mine

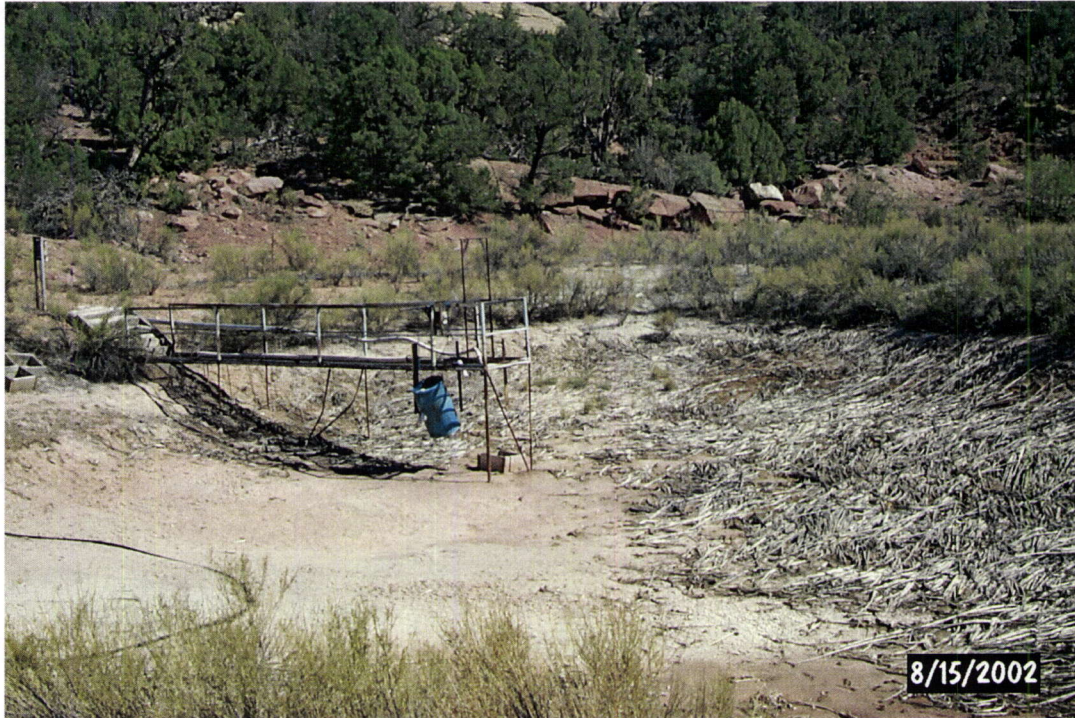
**Photo 1. Pond at the bottom of the water line.**

Mr. Jensen and I looked at the site mostly from a view toward reclamation. In the upper area, there is a very limited amount of reclamation that will need to be done. Basically, it involves removing the headframe, regrading the pond, taking out the water and power lines (assuming the power lines do not belong to Utah Power and Light), ripping and seeding the roads, and reclaiming the vent shafts.

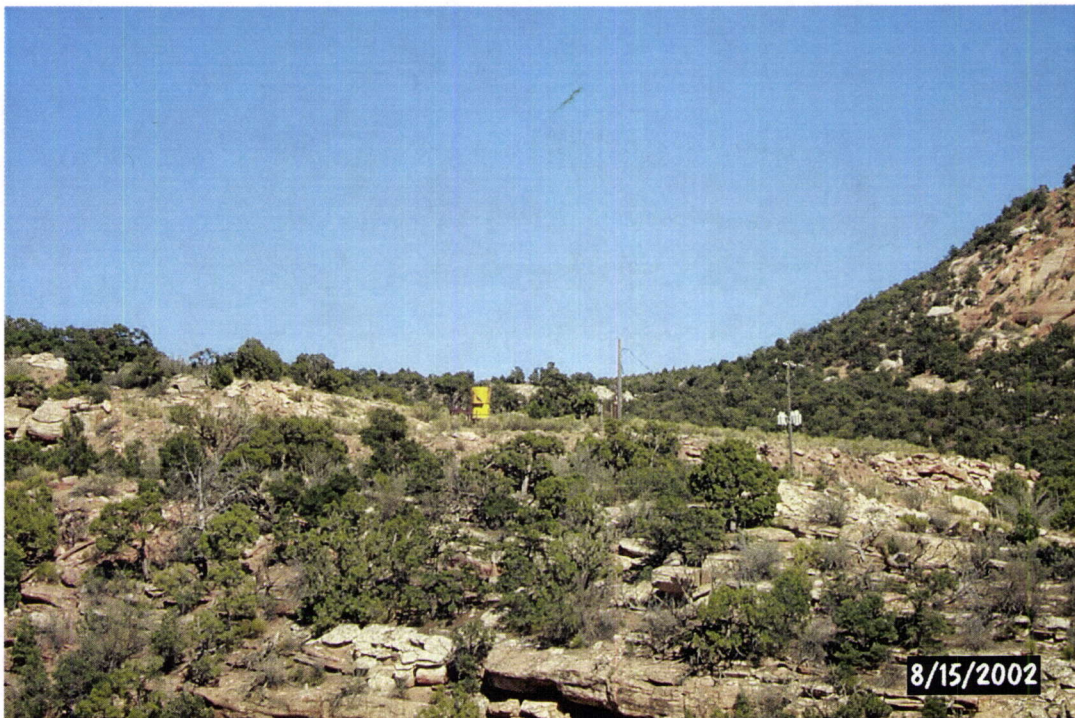
**Photo 2. One of the ventilation shafts is the yellow structure near the center of the photo.**

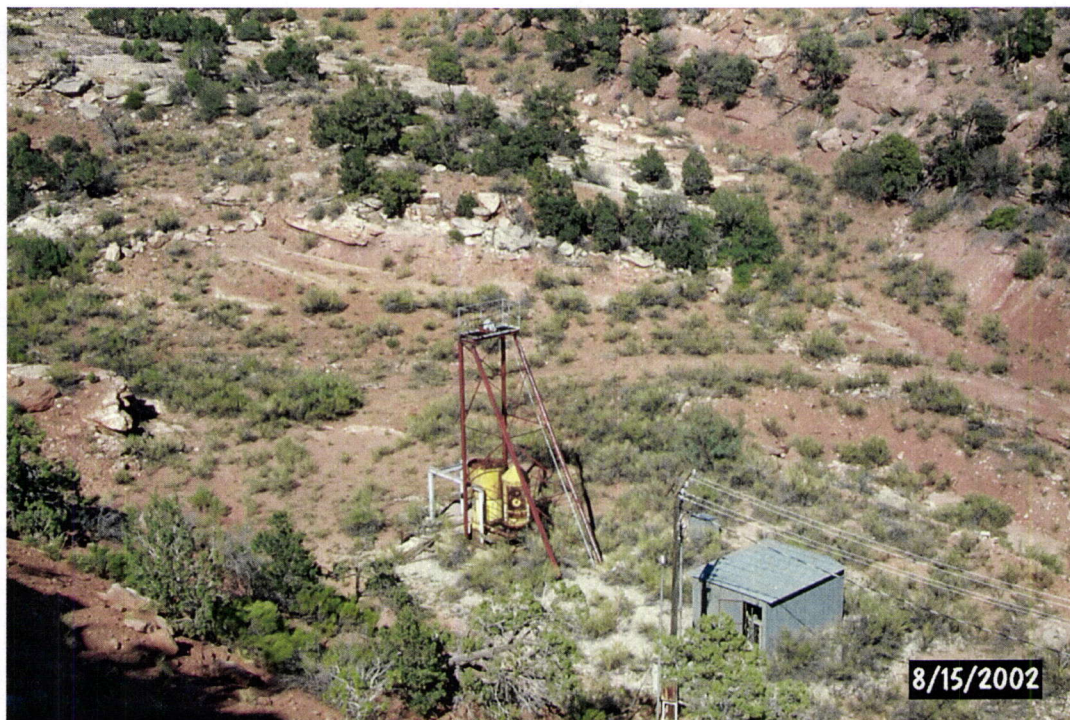
**Photo 3. Headframe and hoist house.**

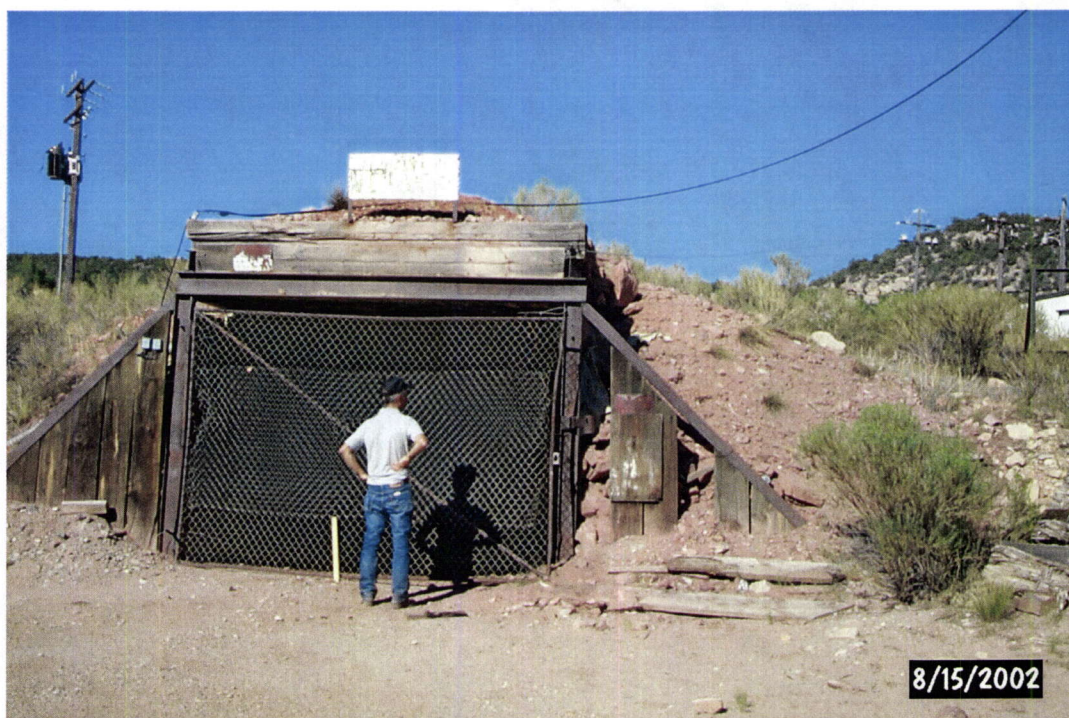
The main facilities area has a waste pile, a portal (Photo 4), some metal buildings, and power lines (Photo 5). The gate in front of the portal is not secured. The transformers in Photo 5 were leaning, and the support structure is in need of repair.

**Photo 4. Portal in the main facilities area.**

The support under the transformers needs to be repaired, and the gate over the portal needs to be secured to prevent unauthorized entry. The berm at the edge of the waste rock pile should be repaired to prevent water from the pad from eroding the outslope.

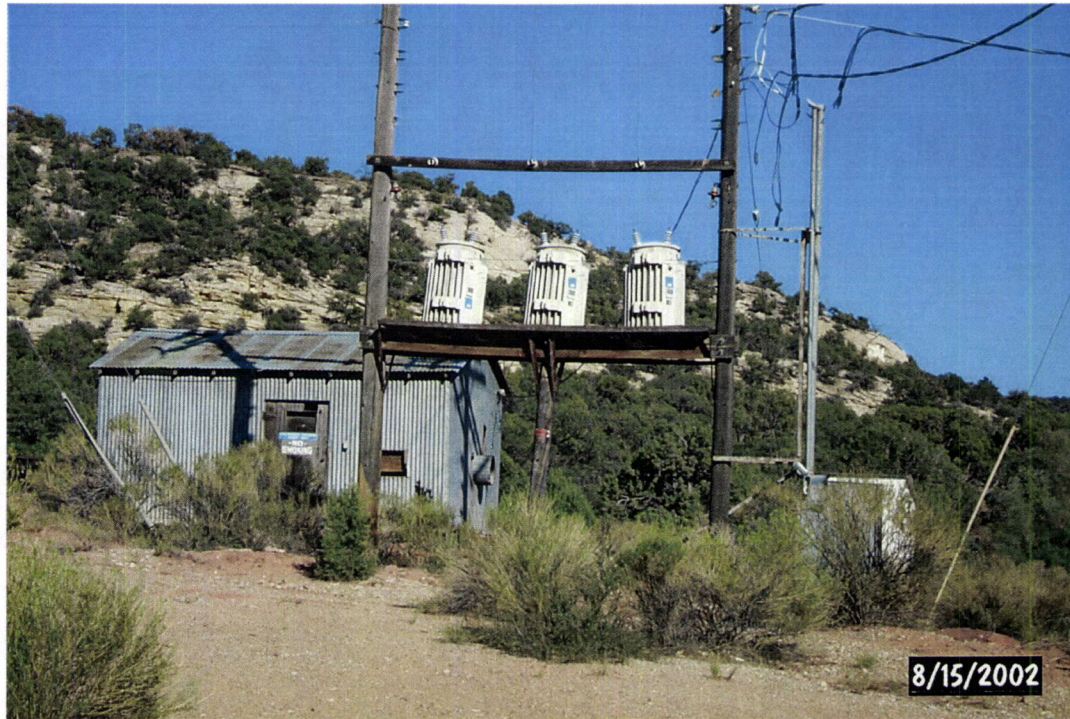
**Photo 5. Transformers at the main facilities area.**

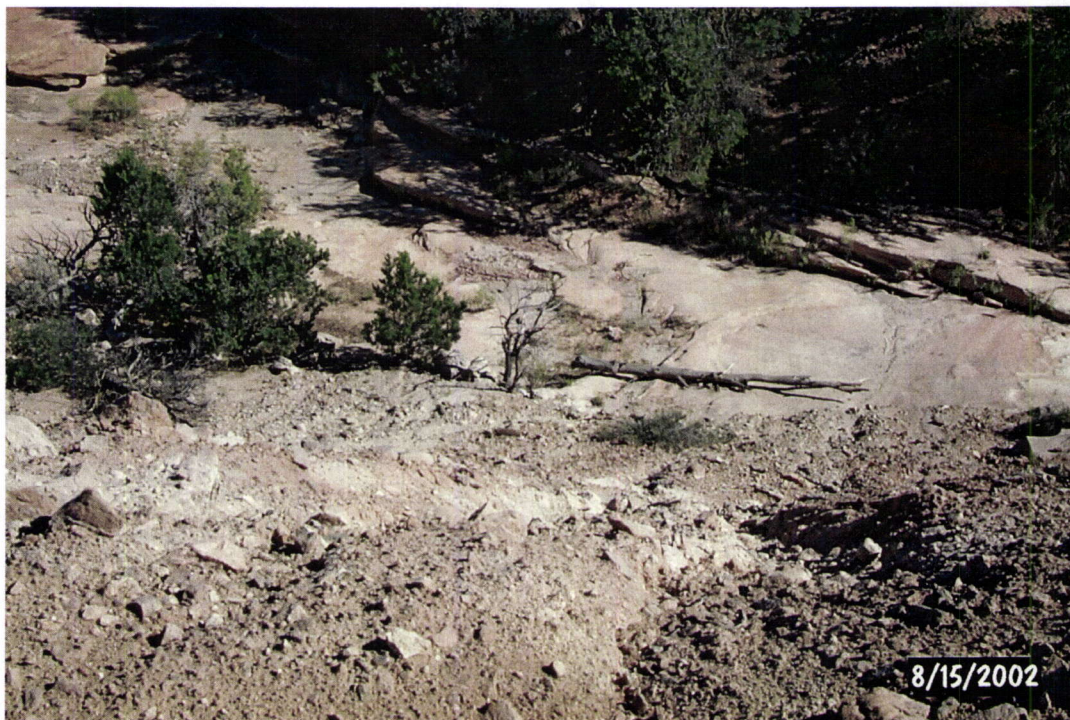
There is a breach in the berm at the edge of the waste pile, and there has been quite a lot of erosion into the wash immediately adjacent to the pile (Photo 6).

**Photo 6. Erosion into the channel next to the waste pile.**

At the main facilities area, the waste pile will need to be graded to reduce the slope and decrease erosion into the channel. Because of the location of the pile in relation to the channel, it will not be possible to push the pile out, but there is plenty of room on top of the pile. Some of the waste will probably need to be brought to the top with a trackhoe, then the pile could be graded to create a more gentle slope.
